# Road Safety Inspection

Olson Memorial Highway (MN HWY55)

July 2024

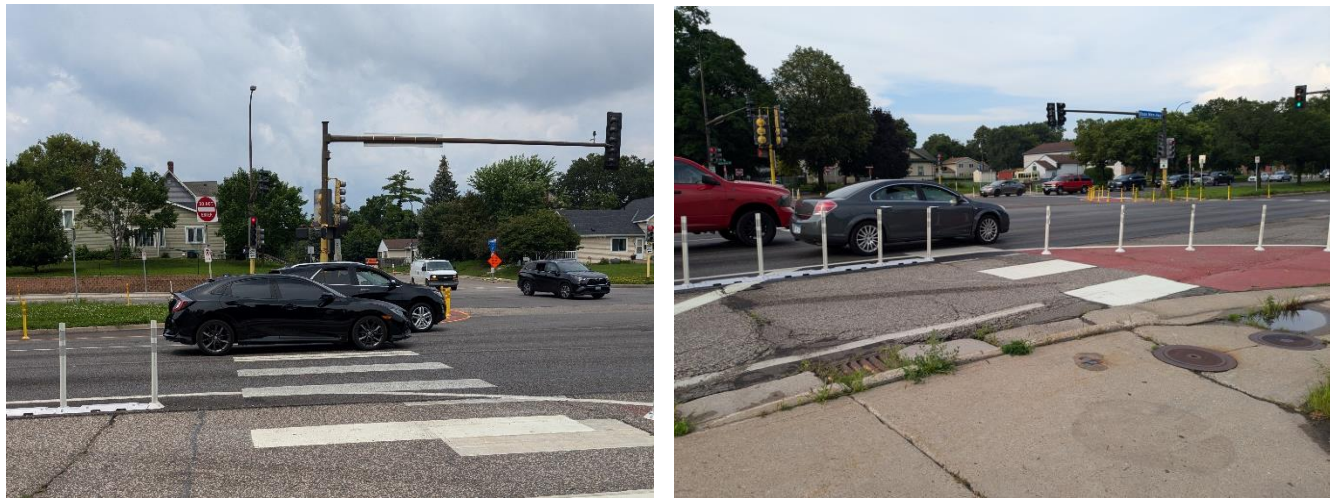
The lack of stop lines coupled with faded or missing marked crossings are causing vehicles to stop on crossing areas or further into the intersection. This issue was noted at several locations on the corridor. When a vehicle blocks a crossing, it compels pedestrians to walk further into the roadway, blocks other drivers' view of pedestrians in the crossing and blocks pedestrians' view of other oncoming vehicles. This issue is possibly exacerbated by the temporary curb extensions that did not also adjust the position of stop lines and crossing points to accommodate the change in intersection geometry. This encourages drivers to inch forward into the now tighter intersection over the existing pedestrian crossings.

Figure 12 Vehicles stopped on the crosswalk during the red phase.

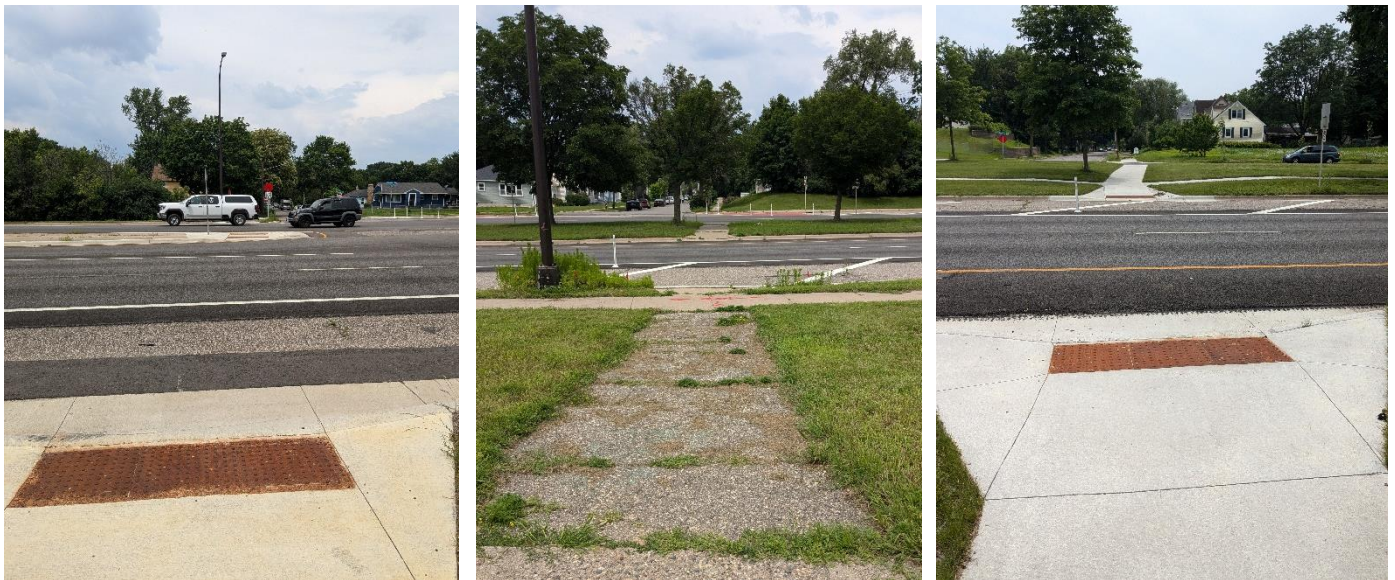
At present these unmarked crossing locations provide no cues to any road user regarding right of way or priority, however the presence of curb ramps and paths leading to the crossing can indicate to pedestrians that these are legal crosswalks or intersections where they do have right of way.

*Figure 13 Examples of unmarked, mid-block crossings on Olson Hwy, including those with newer ADA-compliant ramps as well as older crossings*

- All crossings, regardless of location, should be marked.
- For a multi-lane road like Olson Highway with speeds of 40mph or more and high-traffic volumes, marked, high-visibility crosswalks should be implemented in conjunction with other safety measures (MUTCD 3B.18). These measures include speed reductions, enhanced driver awareness of pedestrians and active warnings of pedestrian presence. Our primary recommendation is to reduce speeds on the corridor (see item 4.1 above)
- Drivers should be required to yield to pedestrians at these locations, and there should be signage and warnings indicating so.

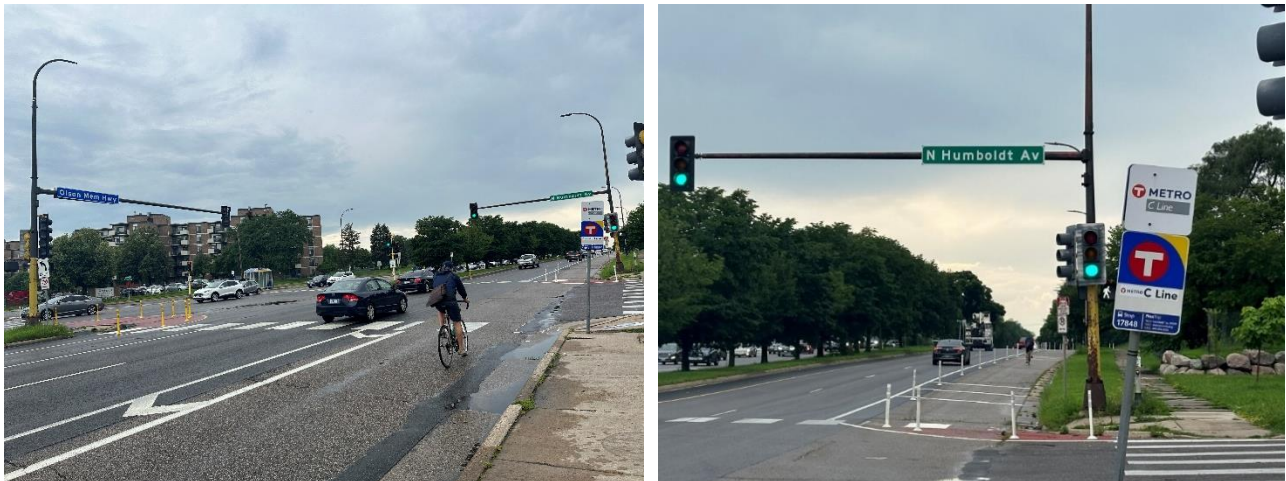
- The use of temporary materials alone does not provide a visual cue to drivers to reduce speeds, since roadway width appears to be the same.
- Temporary plastic delineators or bollards do not provide physical protection for pedestrians or bicyclists attempting to cross the road.
- The closed lane does not currently provide any indication as to whether it is intended to be used by pedestrians and bicyclists. Currently, cyclists occasionally use the lane to travel along the highway. However, the temporary nature of the improvements means that intersections and crossings are not designed to accommodate safe bicycle use on this closed lane. This may give a false sense of safety to cyclists, but also reflects the need for proper, separated cycling infrastructure.

Figure 16 Cyclists using the closed right lane on Olson Hwy

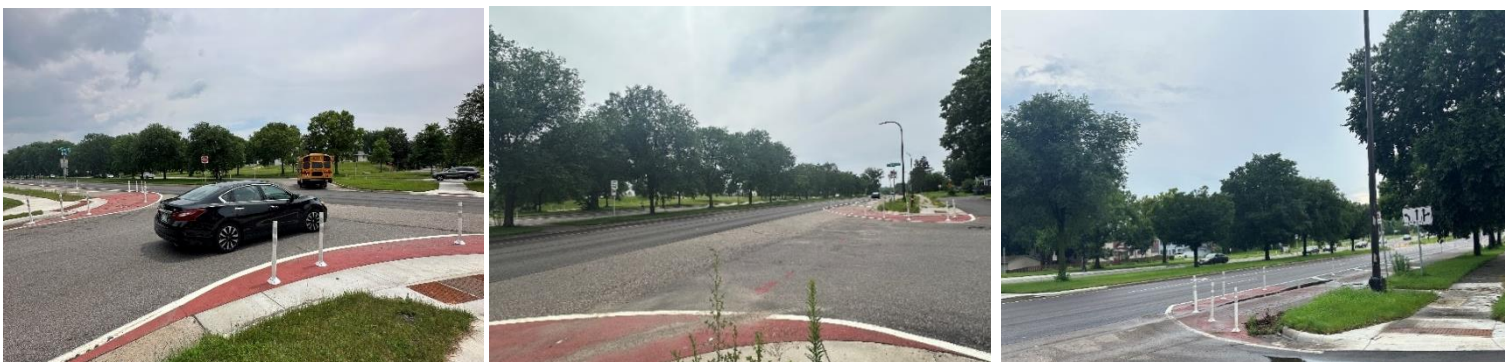
Additionally, curb radii at intersections and medians are wide enough to allow turning at high speeds. This not only increases the risks due to the high speeds, but also increases crossing distances for pedestrians and cyclists. As part of the lane narrowing project, some curb radii along intersection corners and medians were painted red and lined with delineators; however, the new curb radii are still wide and do not provide needed traffic calming and protection for vulnerable road users.

Figure 17 Wide turning radii on turns.

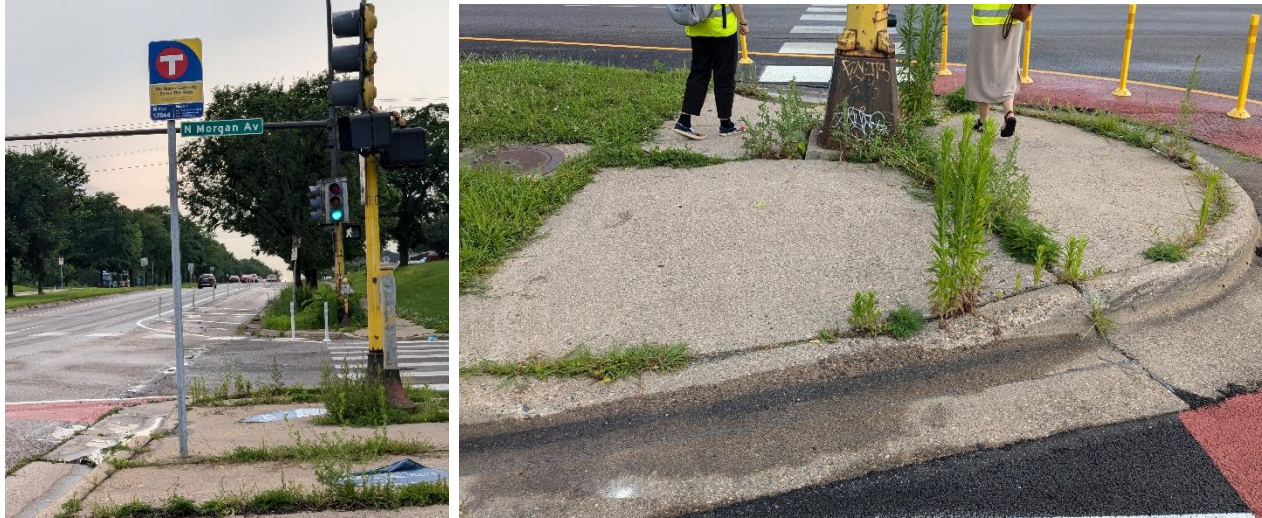
*Figure 19 Poor roadway and sidewalk conditions on the corridor.*

Additionally, infrastructure such as light poles, traffic lights and signposts had rust and peeling paint, which makes for a less visually pleasant environment for walking and biking.

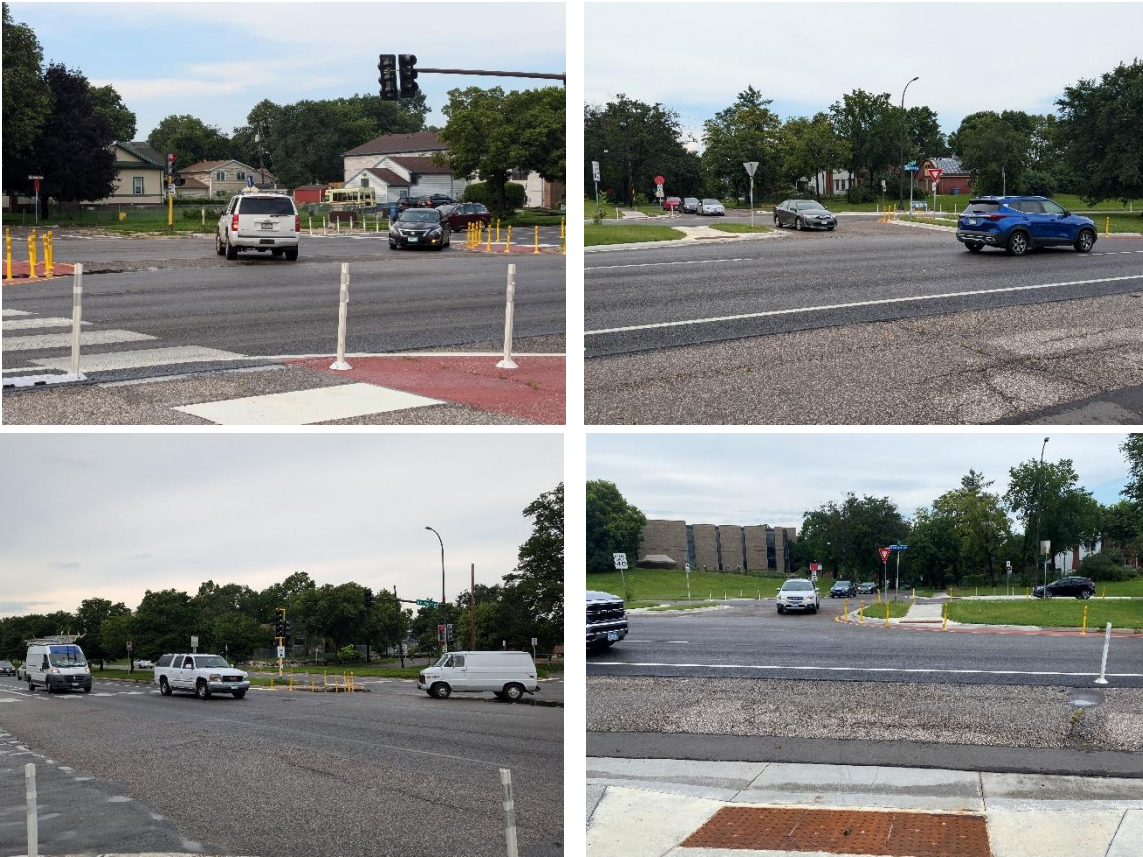
Since there is no dedicated left turn phase at most intersections, there is also no protected pedestrian crossing phase at those locations since left turning vehicles will be in conflict with crossing pedestrians.

*Figure 20 Pictures show vehicles waiting inside of large intersections to make turns, cars queueing to make turns at James Ave., and vehicles attempting to cross both carriageways from the side roads.*

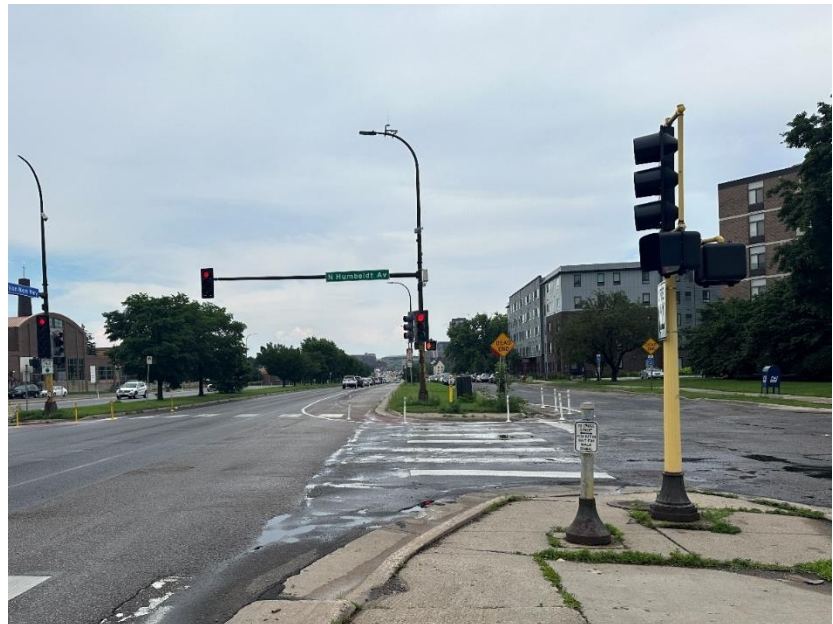
Most signalized intersections along the corridor provide pedestrian signals call buttons to cross Olson Highway, however at several intersections, there are no pedestrian signal buttons for the crossings across the intersecting avenues. This can cause accessibility issues for disabled road users who rely on audible crossing cues.

*Figure 21 Pedestrian signal button on Olson Highway*

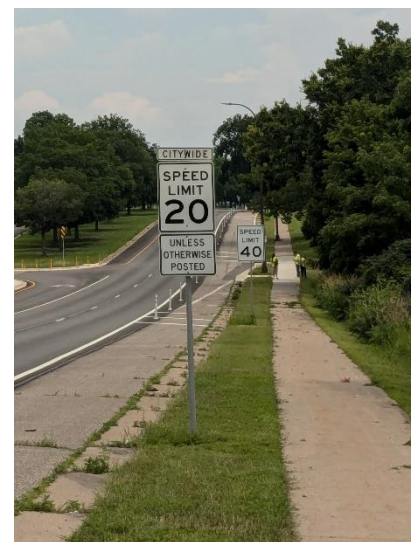
Figure 23 Multiple Speed Limit signs in close proximity.

**Recommendation:** Evaluate whether this is the right location for the citywide limit signage or increase spacing between signs.

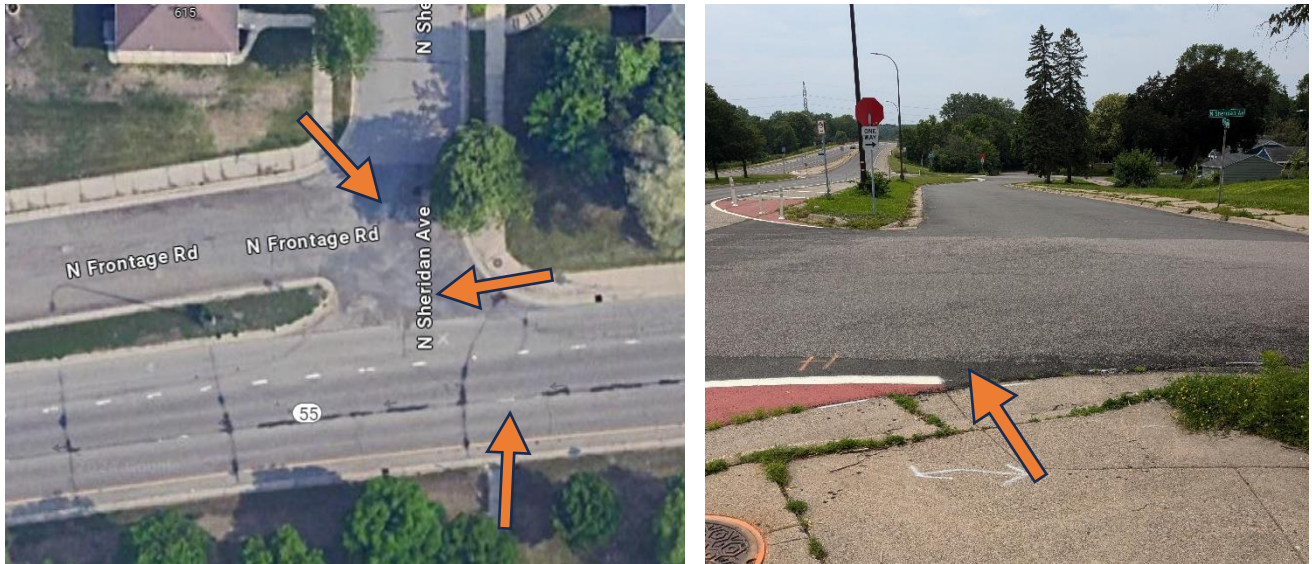
Due to the presence of the frontage road, the sidewalk on Olson Highway ends at a curb cut ramp leading into the junction rather than toward the crossing or adjacent corner curb cut ramp. There are no marked crossings and vehicles turning here can turn at high speeds due to the wide turn radius provided by the curb which can place crossing pedestrians at risk. Misaligned curb ramps and discontinuous sidewalks are especially dangerous for mobility impaired pedestrians or those with other mobility needs.

Figure 24: Arrows indicate location and direction of current curb ramps at Olson Hwy. + N. Sheridan Ave.

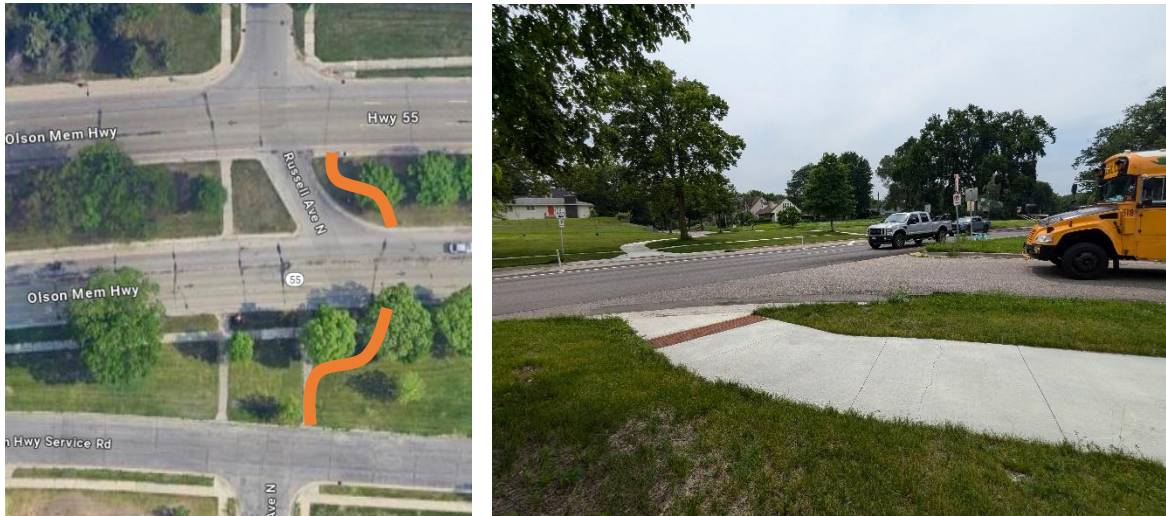
A pre-existing unmarked, unprotected pedestrian crossing is located at this junction. The crossing appears to have been recently split into two paths to allow pedestrian movement on both sides of the median turn. In addition to the general risk of unmarked, unprotected crossings on a 40mph road (as described in the general recommendations) the crossing on the east side (marked in orange below) has an added component of risk for crossing pedestrians, as drivers of turning vehicles are likely looking westward at oncoming traffic as they attempt to merge and may not see crossing pedestrians. Drivers are also likely not to stop or attempt to merge as quickly as possible at speed during breaks in traffic.

Figure 25 Unmarked, unprotected crossing at Russell Ave. Crossing marked in orange may not be visible to drivers merging at speed (For e.g. The school bus merging in the photo at right)

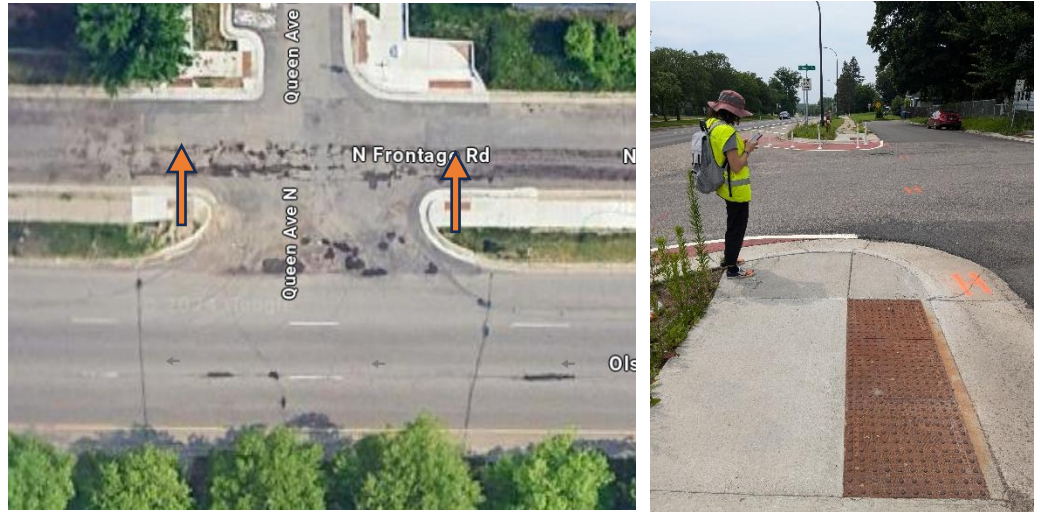
Curb Ramps on the north side of Olson do not connect at Queen Avenue. This can push pedestrians or mobility impaired road users onto the roadway. Moreover, the newly installed plastic bollards used to extend the curb at this location also push pedestrians to walk on frontage road rather than crossing the shortest distance across Queen Avenue.

Figure 26: Curb cuts do not align for crossing Queen Avenue. Bollards also placed in the path of travel when crossing Queen Avenue. (photo on right)

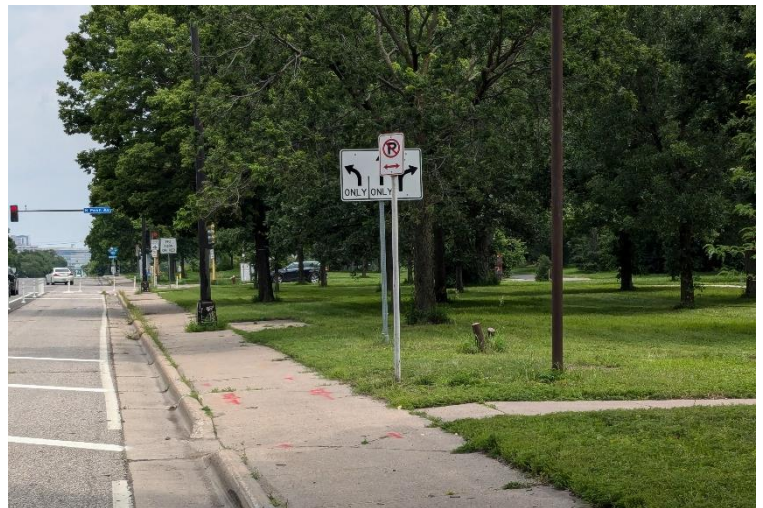
Figure 27 Road signs in close proximity obstructs view of lane control sign.

**Recommendation:** Remove or relocate No parking sign. Lane control signs can also be provided overhead at the junction or on approach.

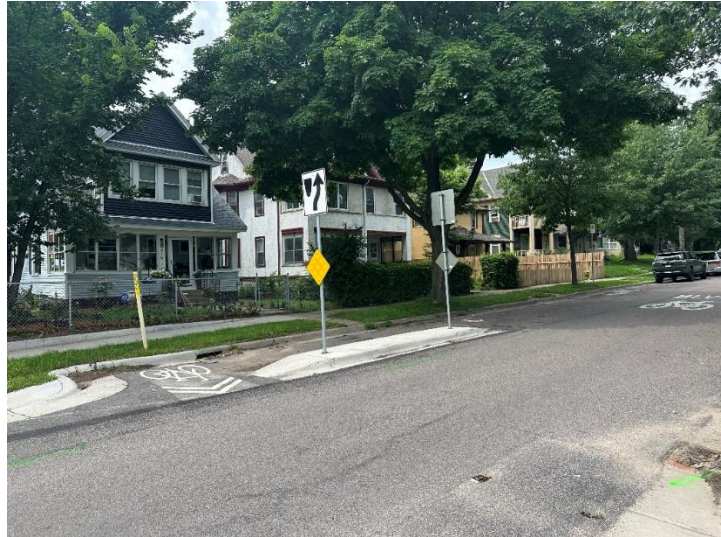
Avenue. by the city of Minneapolis, as well as erroneously marked as a dedicated bicycle right-of way on Google Maps. This may lead bicyclists to cross 6 road lanes + 1 turn lane of Olson Highway at a location where no signage, markings, or signals exist to slow down or warn drivers of bicyclists crossing. Crash data does not show conflicts with bicycles at this location; however, this may be because bicyclists choose to cross at a relatively safer location like the signalized intersection on Penn Avenue rather than at Queen Avenue. Bicyclists or pedestrians choosing to cross at Queen Avenue however are at higher risk of a collision.

Figure 28 Current marked bike route on northern section of Queen Avenue

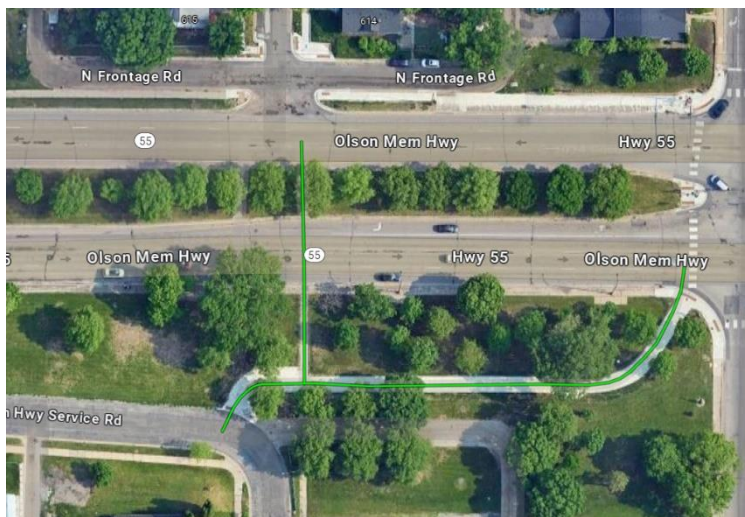
Figure 29 Current bike path and crossings at Queen Avenue. and Penn Avenue

The sidewalk on the northside between Queen Avenue and Penn Avenue should be widened to accommodate bicycles.

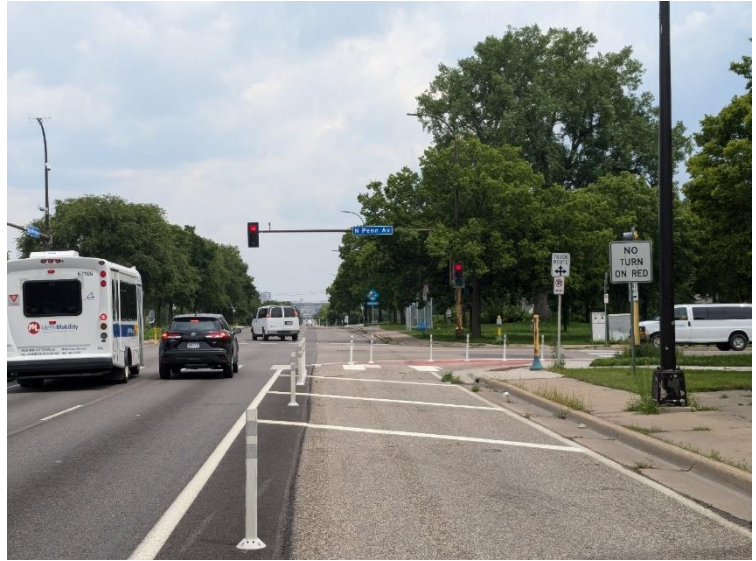
Figure 30 No turn on red sign.

**Recommendation:** The No Turn Sign should ideally be located with the signal or adjacent to the lane from which turns are made. Additional signage can be added to the overhead traffic light.

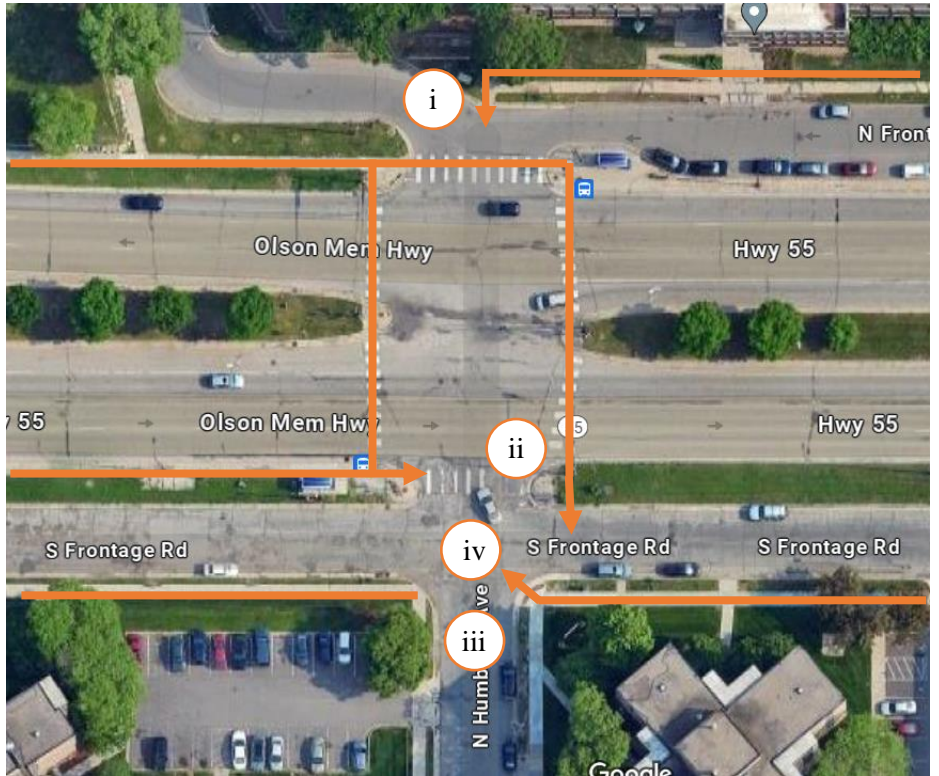
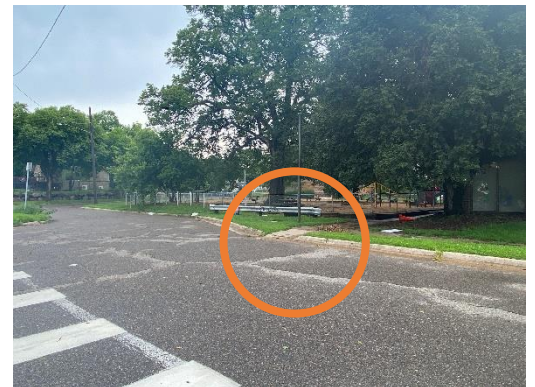
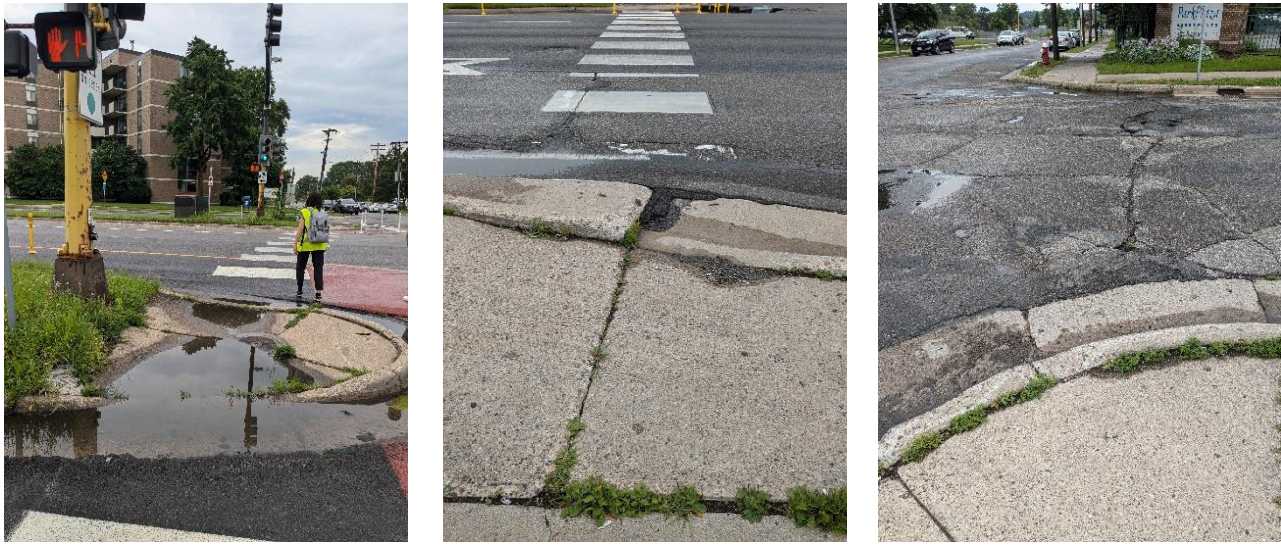
- ii. Rainwater collects at the pedestrian refuge area on the median of Olson Highway which would compel pedestrians to walk on the road in the intersection.

- iii. Sidewalks along the South Frontage Road have missing curb ramps. Curb ramps that are provided do not align with other curb ramps on the median with Olson Highway.

- iv. Existing curb ramps are in a state of disrepair and are not easily used.

Figure 33 Pictures showing water pooling on the pedestrian crossing (left), broken pavement at curb ramp preventing access (middle), missing curb ramps (right)

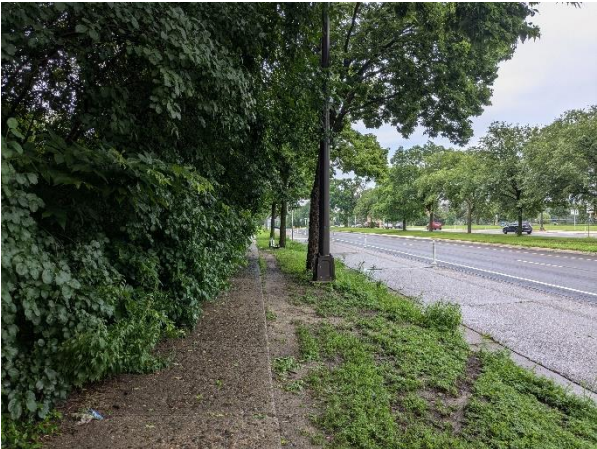
Figure 34 Blocked sidewalk.

**Recommendation:** Trim or maintain vegetation, or work with property owners to keep sidewalks clear if this is on private property.

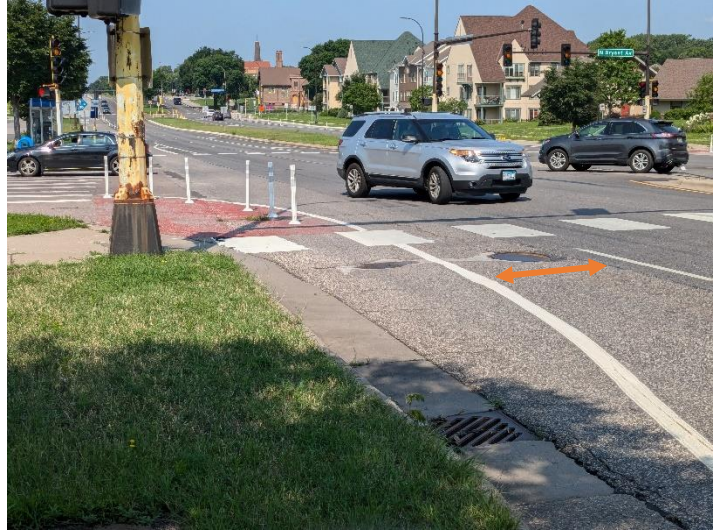
Figure 35 Very narrow lane due to curb extension that does not cover the whole lane.

**Recommendation:** Extend the curb to fully cover the lane if it serves no other purpose. This will shorten crossing distance further.

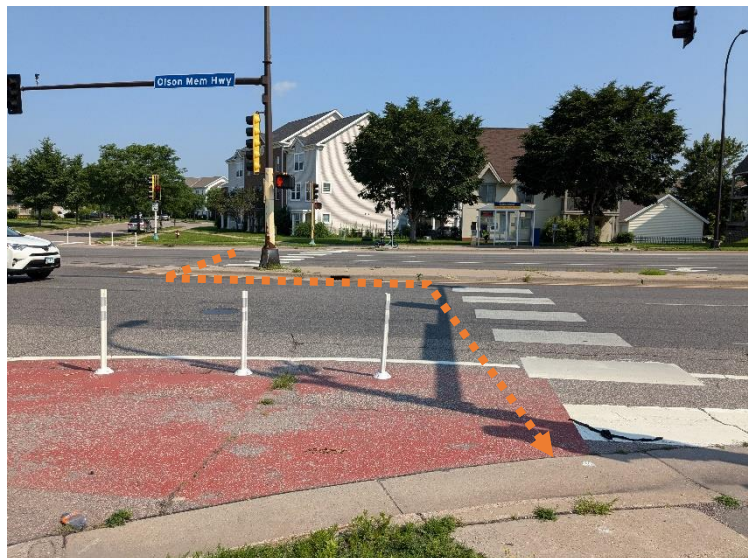
Figure 36 Crossing offset from junction.

**Recommendation:** Align crossings with new curb extension to minimize crossing distance, increase visibility of pedestrians and improve safety and accessibility.

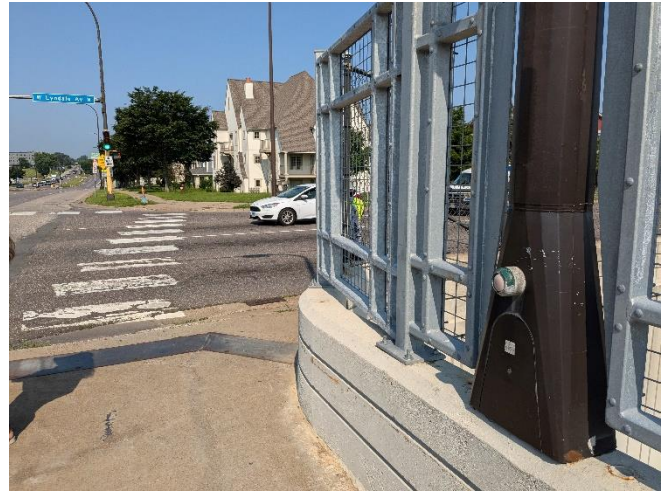
Figure 37 Pedestrian signal button setback from crossing with missing signage.

**Recommendation:** Provide a consistent pedestrian walking environment with functioning and ADA-compliant pedestrian signals and buttons and crossing areas. Signal buttons must be clearly marked and signed.

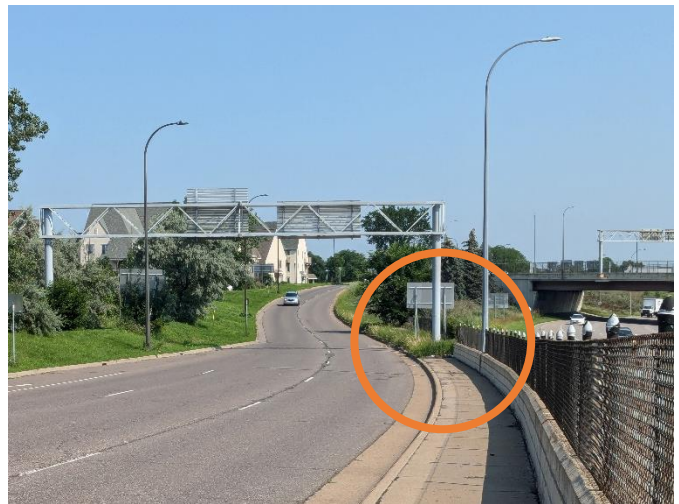
Figure 38 Sidewalk ends with no safe crossing facility.

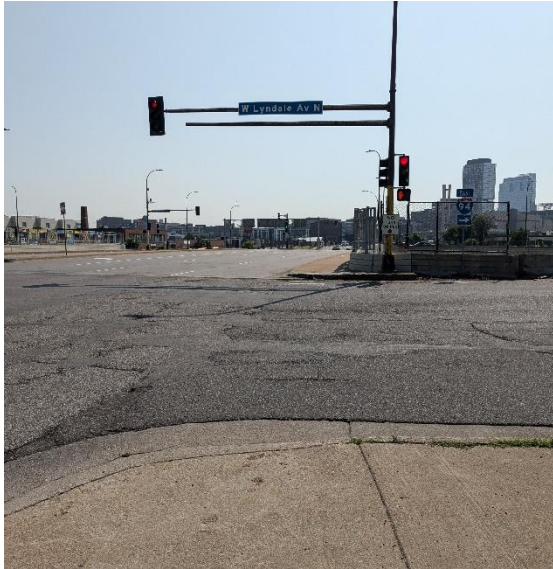
Figure 40 Missing Lane markings and pedestrian crossing.

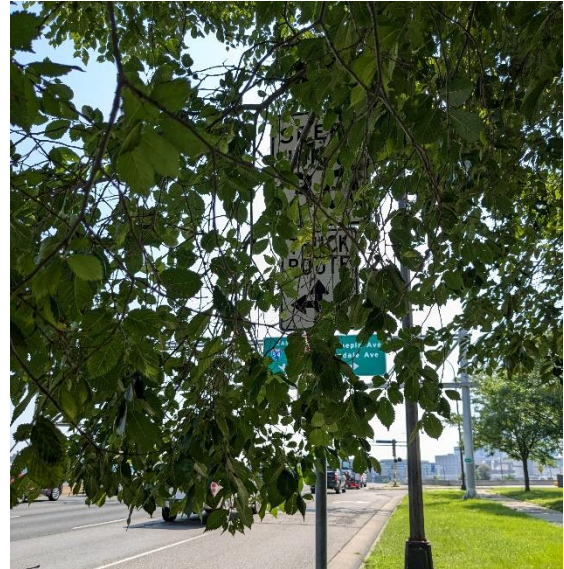
Figure 39 Obscured visibility of speed limit sign.

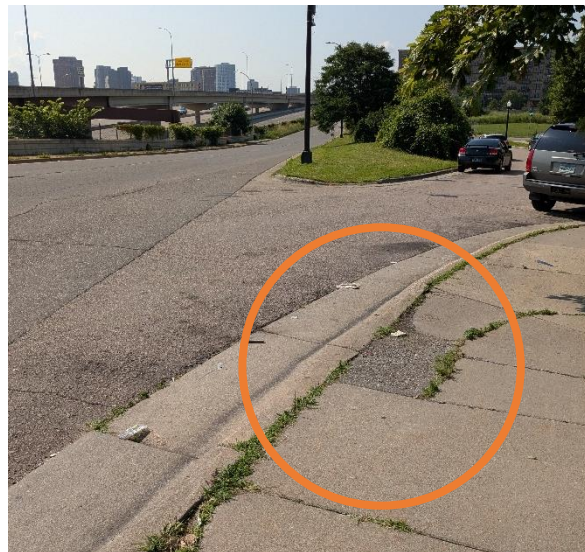
Figure 41 Curb ramp onto roadway and high-speed turn into residential area.

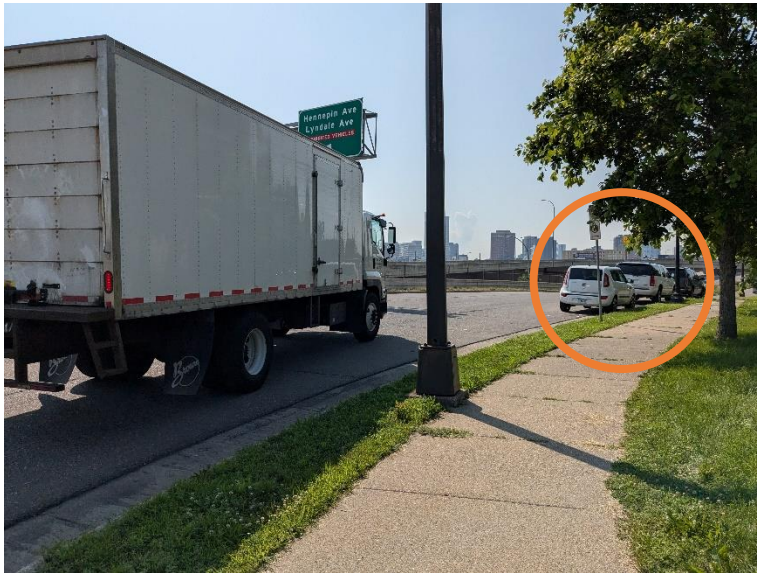
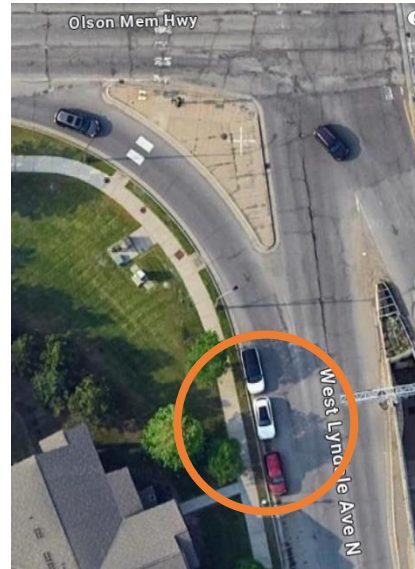
Figure 42 Vehicles parked in the slip lane.

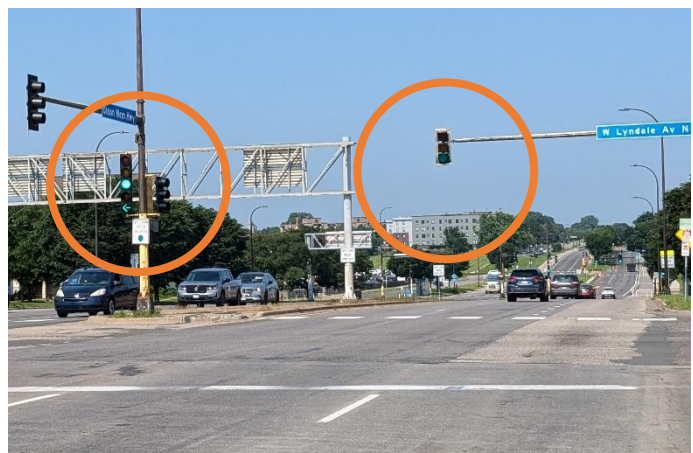
Figure 43 Overhead traffic light not visible compared to post-mounted light.

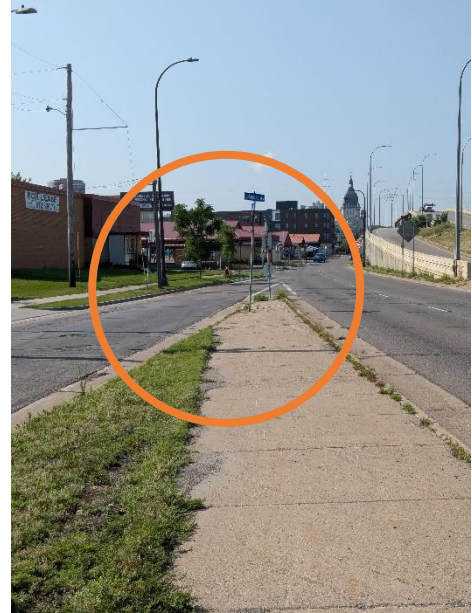
Figure 44 High speed exit design and abrupt end to sidewalk at E Lyndale N and Lakeside Ave.

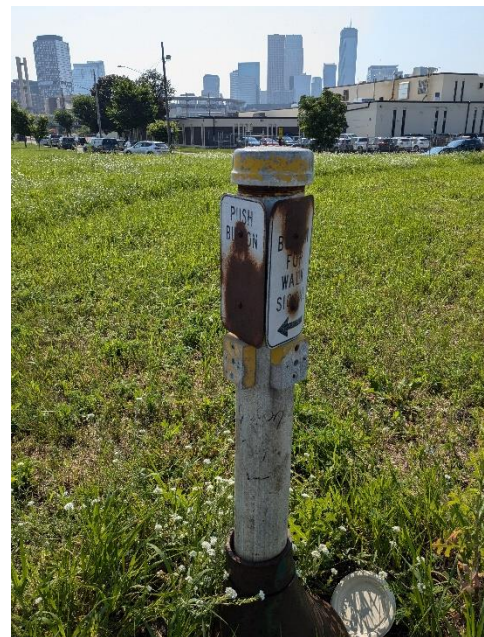
Figure 45 Missing buttons and poor maintenance of pedestrian facility.

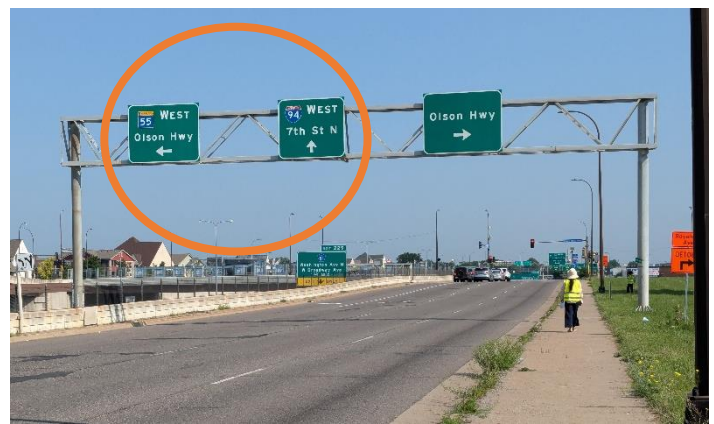
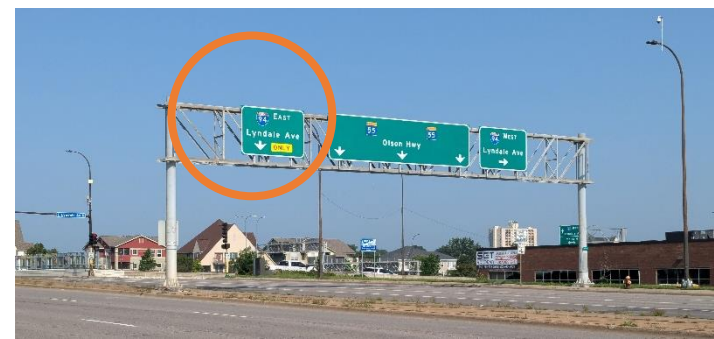
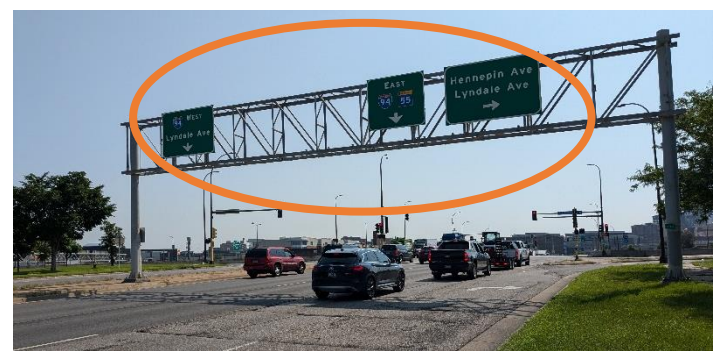
Figure 47 Above: (i) Approach from E Lyndale N Ave  
Below: (ii) Approach from Olson Hwy/6th Ave  
Bottom: (iii) Approach from Olson Hwy from the west

- i. On the approach from Lyndale Avenue. provide signage indicating that left-most lane is a turn-only lane.
- ii. On the approach from Olson Highway/6<sup>th</sup> Avenue. provide signage indicating left-most lane is a left turn-only lane.

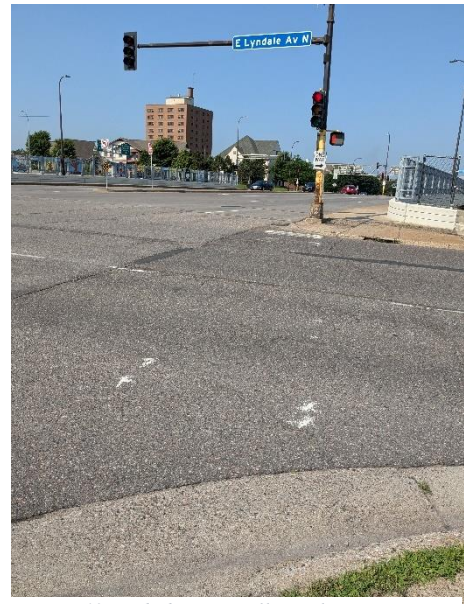
Figure 49 Faded crosswalk marking.

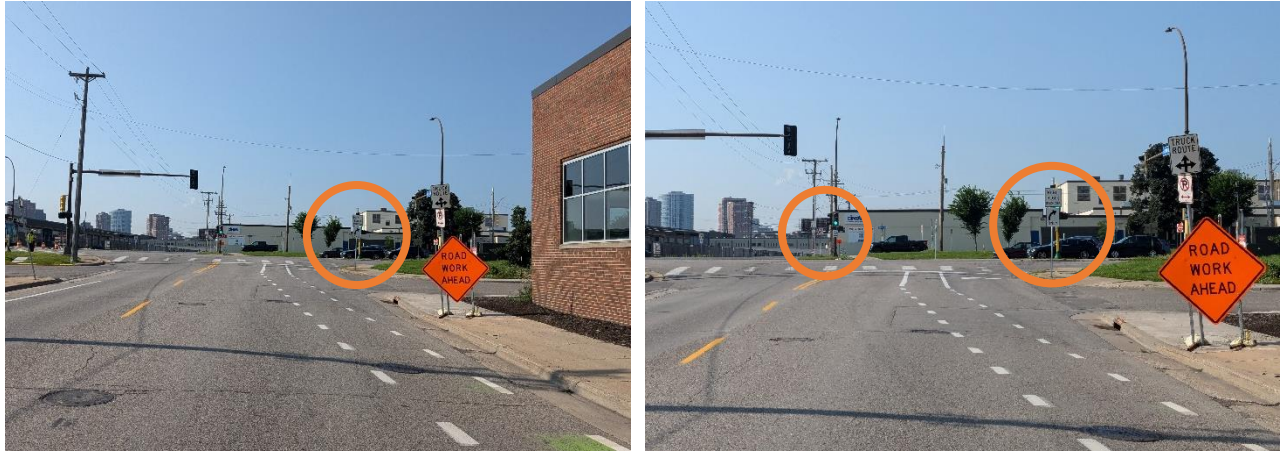
Figure 50 Driver view on approach to the intersection showing view of signals. Signal on the right has obstructed visibility.

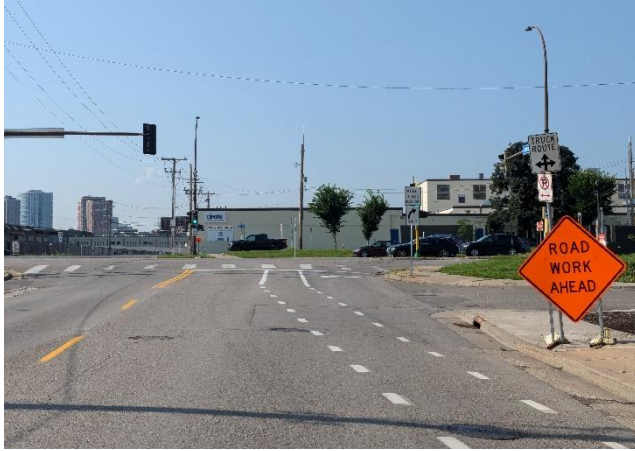
Figure 51 Missing marking and signage for through bike lane.

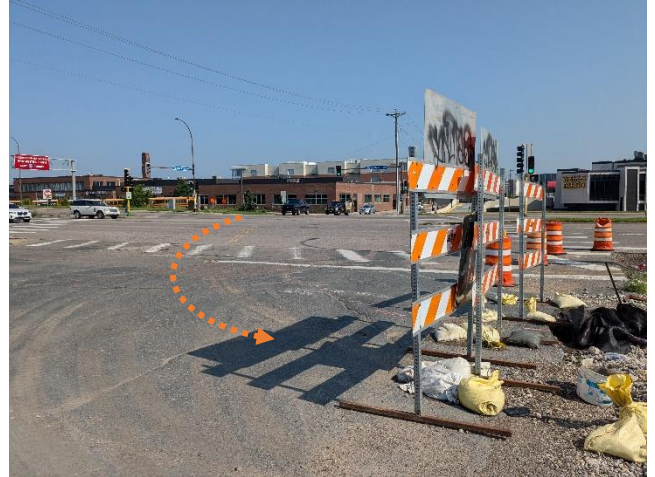
Figure 53 Incorrect yellow line extension marking.

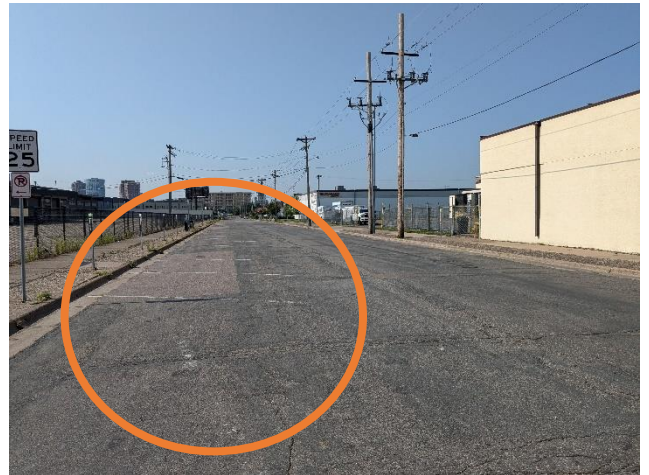
Figure 54 Faded parking and road markings.
