# Road Safety Inspection

Olson Memorial Highway (MN HWY55)

July 2024

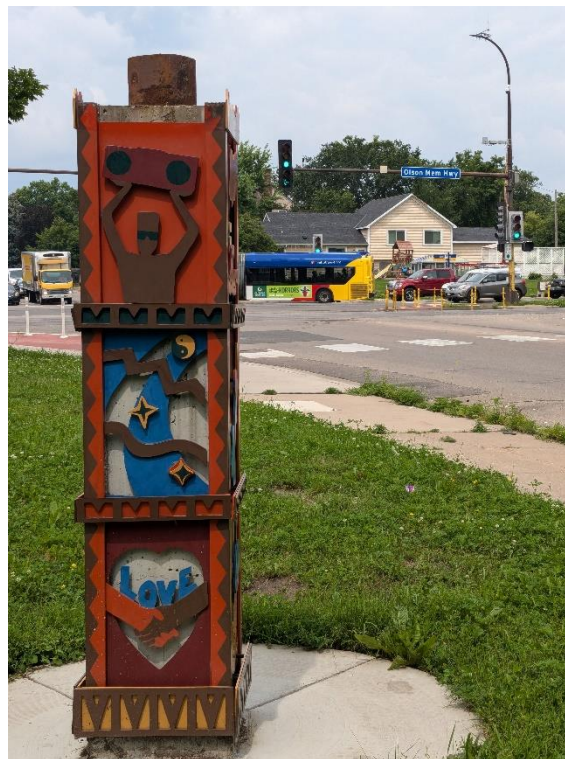
Figure 1 Olson Hwy at Penn Avenue.

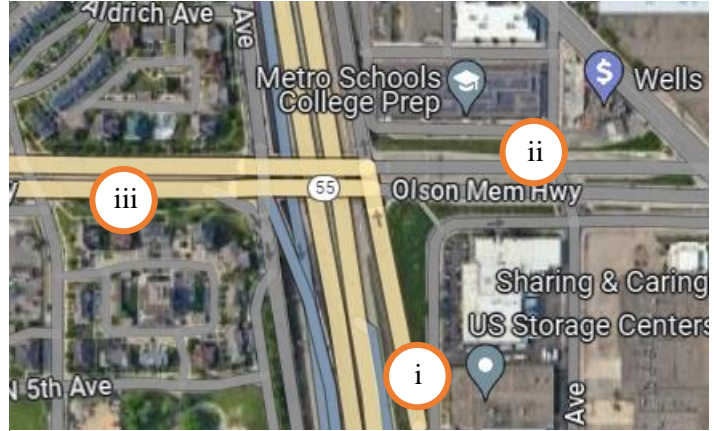
(iii) Similar issues are noted on **W. Lyndale Ave** headed East on Olson Highway. Drivers heading to I-94 East are expected to make a turn at the intersection after the slip lane, but no such guidance is provided. Right lane is not marked as a turn only lane. No signage is given for through traffic lanes. No indication provided that I-94 West is a left turn ahead.

Figure 46 Map indicating locations of issues labelled i, ii and iii

**Recommendation:** Provide appropriate signage indicating appropriate use for each lane. This will prevent driver confusion and rapid merging or lane changes that lead to collisions. Having signage indicating use for each lane on the approach has a better safety benefit.

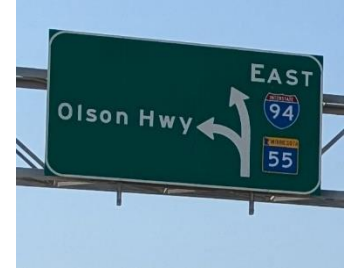
Figure 48 (right):

*Example of type of directional signage used on W Lyndale that may be suited for use on Olson. Sign can be used to indicate two left turns - one to I-94 and one to Southbound Lyndale Avenue, instead of the current sign which uses only one arrow.*

Provide additional signage and missing road arrow markings after the intersection with E Lyndale and Olson Highway to indicate the correct lane and left turn to the I-94 entrance ramp. Direction signs such as in Fig. 47 may be more appropriate.
